The Geomorphological Hazard of Machu Picchu Citadel and Aguas Calientes Village

A practical application to assess the natural risks which the Inca citadel of Machu Picchu and the Aguas Calientes village (Cusco, Perú) are subject to was carried out under the INTERFRASI and FORGEO projects. The area is prone to debris flows, low angle rock slides, high-angle rock slides and rock falls. The development of landslides in the bedrock is influenced by the orientation of the joint sets with respect to the topography, whereas those in the coverage essentially depend on the slope angle. The triggering mechanisms are to be found in seismic activity and intense precipitation. In the past, landslides have seriously damaged the archaeological and especially the civil structures, and in Aguas Calientes there have been many casualties. For this reason a procedure to understand the vulnerability and the risks for the anthropic exposed elements, both archaeological and civil, was adopted

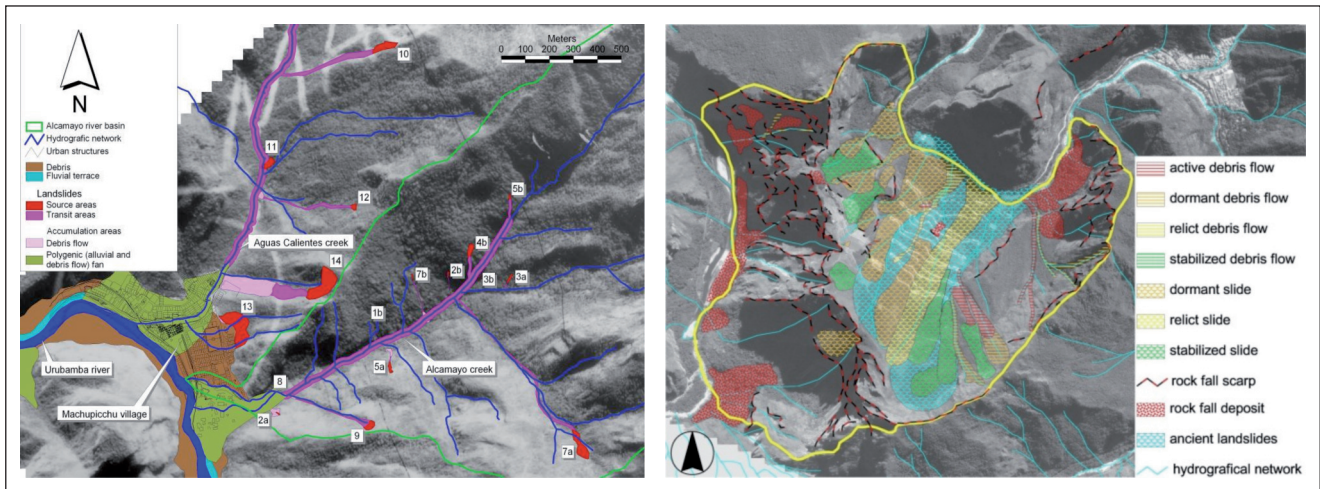
FIGURE 3 Landslides inventory in the areas of the Aguas Calientes village and the Machu Picchu citadel
Source: ENEA

The Machu Picchu Sanctuary is regularly affected by several slope instability phenomena (Canuti et al. 2005; Carreño and Kalafatovich 2006; Vilimek et al. 2007; Carlotto et al. 2009; Puglisi et al. 2011): rock falls, high-angle rock slides, low angle rock slides and debris flows (Fig. 3). Kinematic conditions for landslide type and evolution are closely depending on structural and topographic factors. Besides the structural setting, rock falls and slides are highly dependent on the geomorphological evolution and anthropic activities and are mainly triggered by regional seismic activity. Instead, abundant local rainfall is the main triggering factor for debris flows due to the rapid saturation of the shallow portions of the soil layer.

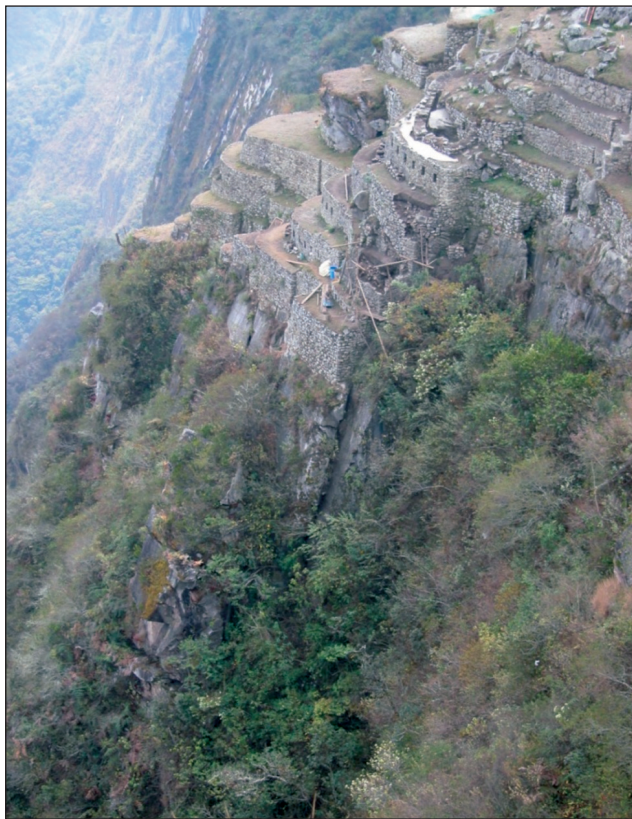
FIGURE 4 Open fractures in the SW flank below the Inca citadel
Source: ENEA

Other landslides of type A are inside the citadel along the structural system with orientation 30° and slope 30°, but are currently inactive. Their activation can be dated before the citadel construction, being stabilized during the construction. Also the NE flank below the Inca citadel is affected by type A landslides, that develop prevalently along the 30°/30° and 30°/60° structural sets. The intersection of slope orientation with the structural system makes the slope evolution active with a retrogressive distribution of activities, with slow evolution. The entire SW side has an almost vertical slope and the pattern of joints is determined by the intersection between the 225°/65° and 130°/90° systems (Fig. 4). The frequent open fractures and the

current deformation of the archaeological structures (andenas) implies that type B landslides are active, and therefore the hazard related to this portion is high. A different approach was used to evaluate the hazard relating to landslides of type C, because these have neoformation character and because they are responsible for the damage and the casualties that occur almost every year in Aguas Calientes. A parametric approach was used to assess the debris flows hazard (Casagli et al., 2004; Abbattista et al., 2005; Leoni et al., 2009), and the base maps produced for the analysis are constituted by: a landslides inventory; a Digital Elevation Model with a 5 m grid. Comparing the landslide inventory and DEM derived maps, slope and aspect classes of the areas affected by landslides in the past have been identified. Two general trends for the source areas have been identified: high angle phenomena occurring on the steeper slopes (50° - 70°), where soil is moderately thick, and low angle phenomena with thicker soil bodies lying on smoother slopes (25° - 55°). Debris flow hazard maps of both types have been produced for the Alcamayo catchment (Fig. 5).

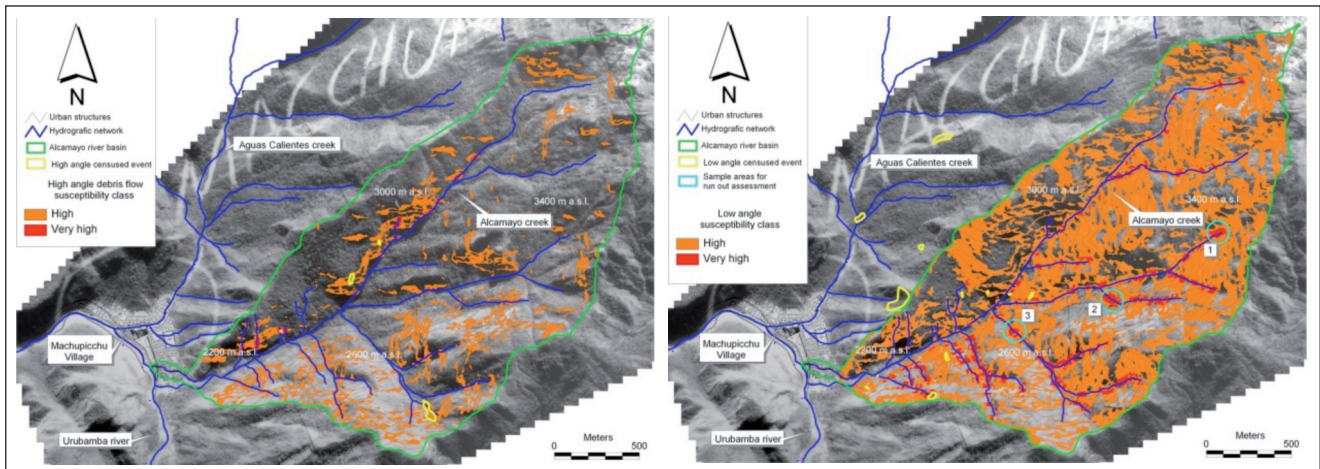
FIGURE 5 High angle (left) and low angle (right) debris flow hazard maps in the Alcamayo catchment above the Aguas Calientes village
Source: ENEA

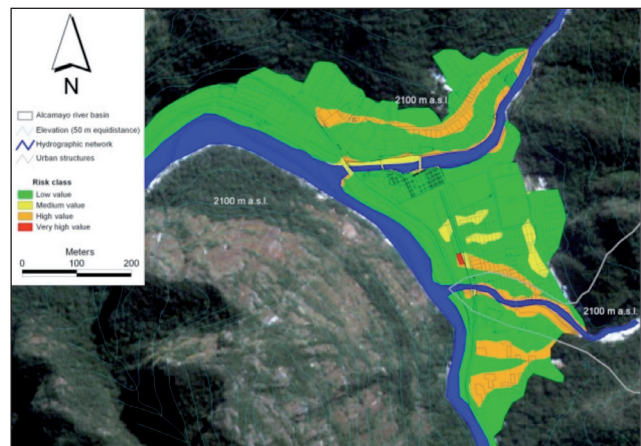
In the village of Aguas Calientes, buildings located in the morphological depression near the railroad station are in the higher risk areas (Puglisi et al. 2011; Fig. 8). Another important risk for the lower part of the village involves constructions on the banks, very close to the river water level. This scenario raises the damaging potential of the Vilcanota river floods. If a debris flow, originating from one of the tributaries, dams the river downstream of the village, the Vilcanota water level could increase and flood Aguas Calientes. Material accumulated by previous debris flows on the

FIGURE 8 Debris flow risk map in the Aguas Calientes village
Source: ENEA

These critical conditions have been further worsened by the rapid urban development over the last few decades. The depressed zones of the fan present an elevated residual risk level and the railway station is characterized by the highest risk of debris flow. At present, aside from proper territorial planning and

the restriction of new settlements, a program that includes real-time monitoring and effective alert and evacuation tools seems to be necessary. The results of both projects have been useful to administrative authorities involved in natural risk management in the Machu Picchu area.
