Cliffs and quarries in the eastern coast of the Favignana island (Sicily, Italy)

DOI 10.12910/EAI2015-071

■ L. Falconi, A. Peloso, A. Screpanti, A. Tati, V. Verrubbi

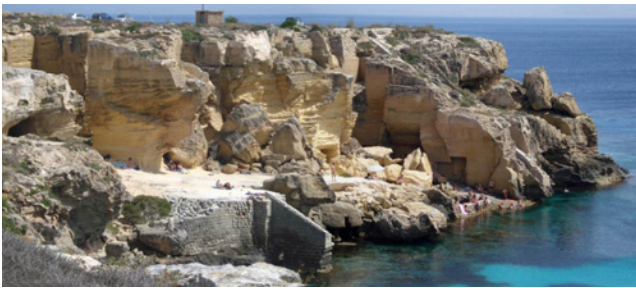
FIGURE 2 Rock blocks fallen at Cala del Bue Marino

is presumably below sea level. The overlapping of hard rock masses on a more plastic substratum leads to mechanical instability due to the diverse response of the materials to perturbations, such as seismic input, weathering, erosion or man-made excavations [14]. The resulting mass movements can be classified into two different but strictly interconnected typologies: lateral spread and rock blocks fall [15].

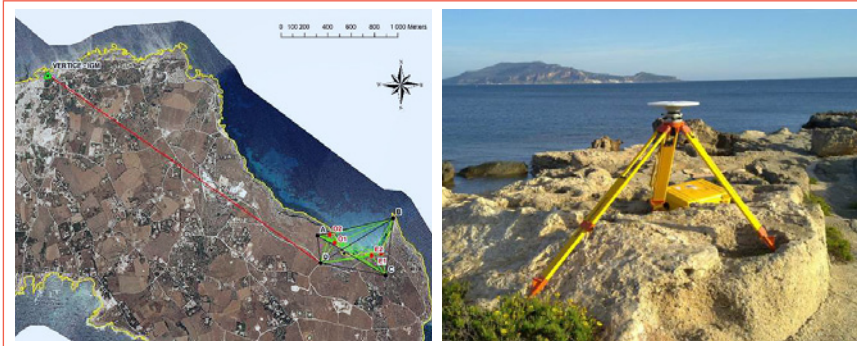
FIGURE 5 The local GPS network and one of the measurement points

The GPS network is composed by four stable vertices (A, B, C and D in Figure 5), while in proximity of the edge of the cliffs four sites were chosen, considered potentially unstable after a geomorphological survey (E1, E2, O1 and O2). The GPS network was linked with the Italian Geodetic Network (IGM95), by the geodetic point “Punta San Leonardo” located close to the Favignana’s urban area. The uncertainty of these vertices was very contained, reaching a maximum of +/- 2 mm in plane and +/- 3 mm vertically.

vertices it is possible to observe a vertical millimeter movement, even if inside the ellipse error, that denotes a presumable subsidence trend. The data acquired during the fourth survey, performed in June 2015 and still under processing, will allow to compare a more significant dataset and better understand the behaviour of the cliffs.

movement of the four unstable vertices may be observed, but always inside the error ellipse and without an apparently defined trend. Only for E2 and O2

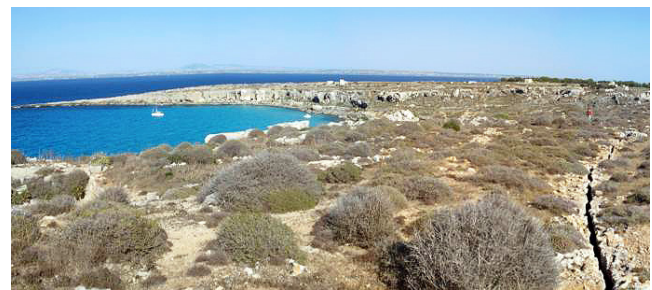
From the front slope towards the interior of the slab, the rock fracturing condition becomes less intense, with spacing ranging from less than 1m up to more than 2m or more. This may be appreciated both in the plateaux above the cliffs and within the several quarries opened inside it. Nevertheless, in the inner part of the west side of Cala Rossa cliff, upon the plateaux and approximately 25 meters from the edge, two major discontinuities have been recognized, longer than

100 meters, 50 cm open and with 40 cm of offset. These joints seem to reach the contact with the underlying clays, isolating a huge block of approximately 30 thousand m³ (Figure 6).

FIGURE 6 Giant joint of Cala Rossa

Removal of the most unstable blocks, local rock nailing and protection boulder walls at the foot of the cliffs are all interventions that can reduce the general unstable conditions in the higher hazard level sectors of the cliffs. In the most critical areas, as the west side of Cala Rossa, a partial prohibition of access is strongly recommended. Furthermore, improving the current monitoring system is a necessary prerequisite for future adoption of an early warning system.

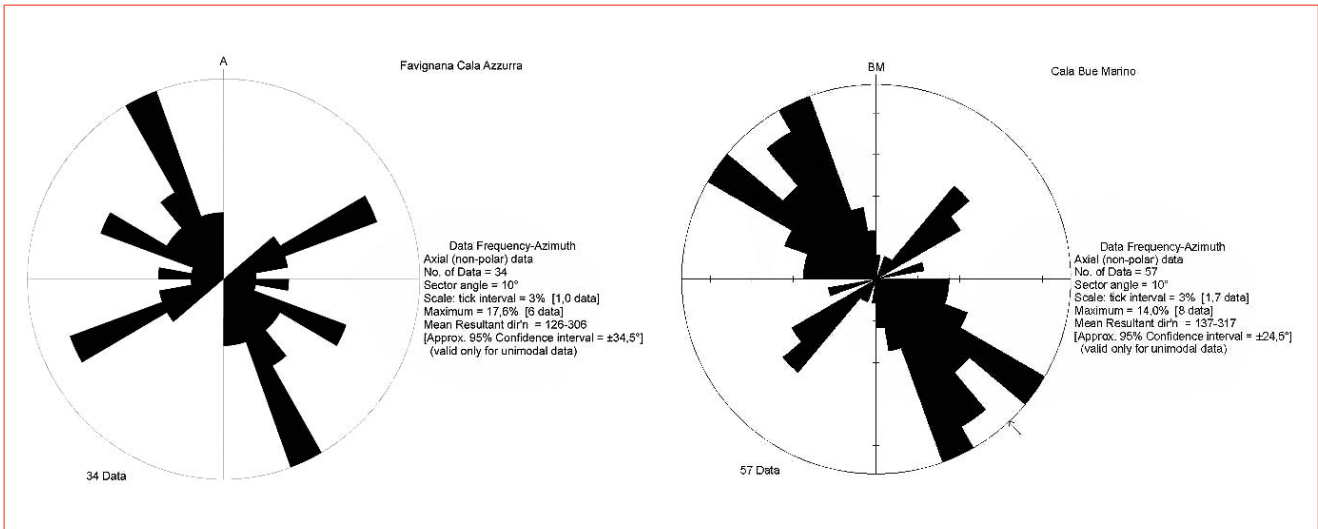
Structural analysis confirms the presence of two main joint families: NNW-SSE and NE-SW (Figure 7 and 8). The NNW-SSE joint set seems to have a significant relevance in the structural asset of the area and in the development of the instability proneness. Especially where this joint set is parallel to the slope face, it is possible to recognise an advanced lateral detensioning deformation process. Less significance seems to have the sub-horizontal stratification planes. Taking into account the attitude of the main measured joint, two failure mechanisms have been assumed for the movements in the front part of the cliffs: rock topples and rock wedge slides.

FIGURE 7 Discontinuities plot of Cala Azzurra (left) and Cala del Bue Marino (right)

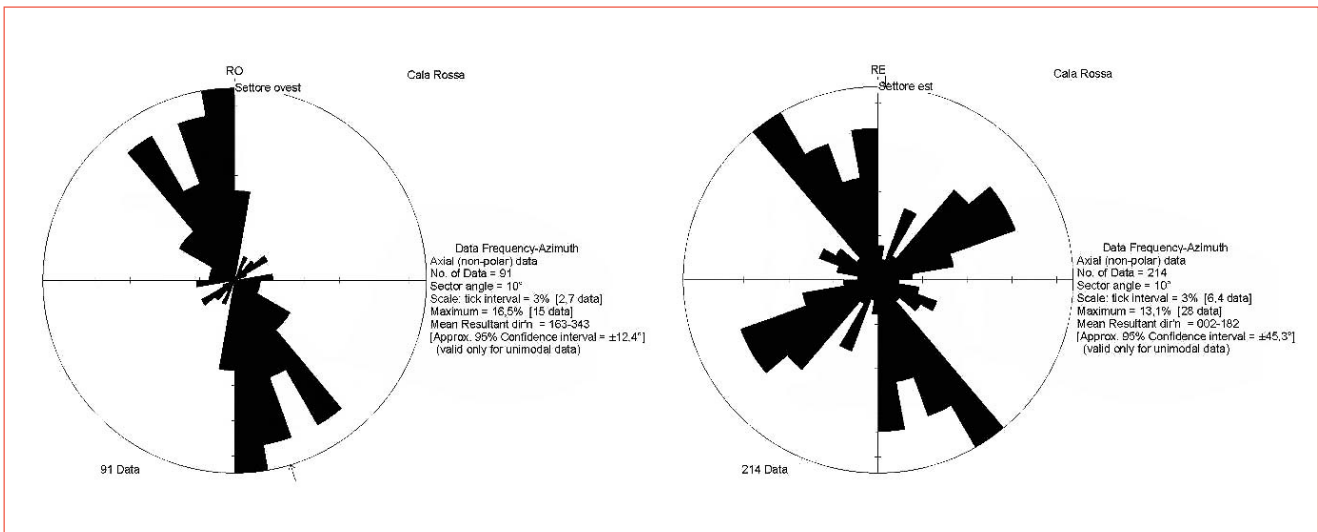
FIGURE 8 Discontinuities plot of the two side of Cala Rossa (West on the left and Est on the right)

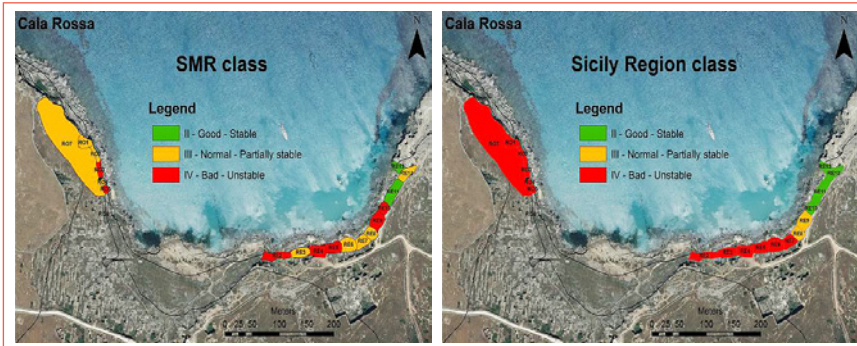
the cliffs in the study area. The comparison between the traditional classification of Beniawsky/Romana (RMR/SMR) and the recent experimental classification of Sicily Region (SR) showed a moderate agreement in the results (Figure 9).

FIGURE 9 Maps of Slope Mass Rate (left) and Sicily Region classification (right)

The rock mass rating of the cliffs attributed to the different measuring stations (Figure 9) shows good agreement between the SMR and SR classifications, even if the latter appears to be more conservative. It is notable that attributing the SMR and SR classes demands to take into account the geometrical relationship between the most significant joint planes and the slope orientation. Even though the analysed cliffs of three bays have strongly indented forms, due to natural and human causes, in this study only an average value of the slope orientation has been used. Consequently, the SMR and SR classes assigned to a station are affected by a certain level of approximation.

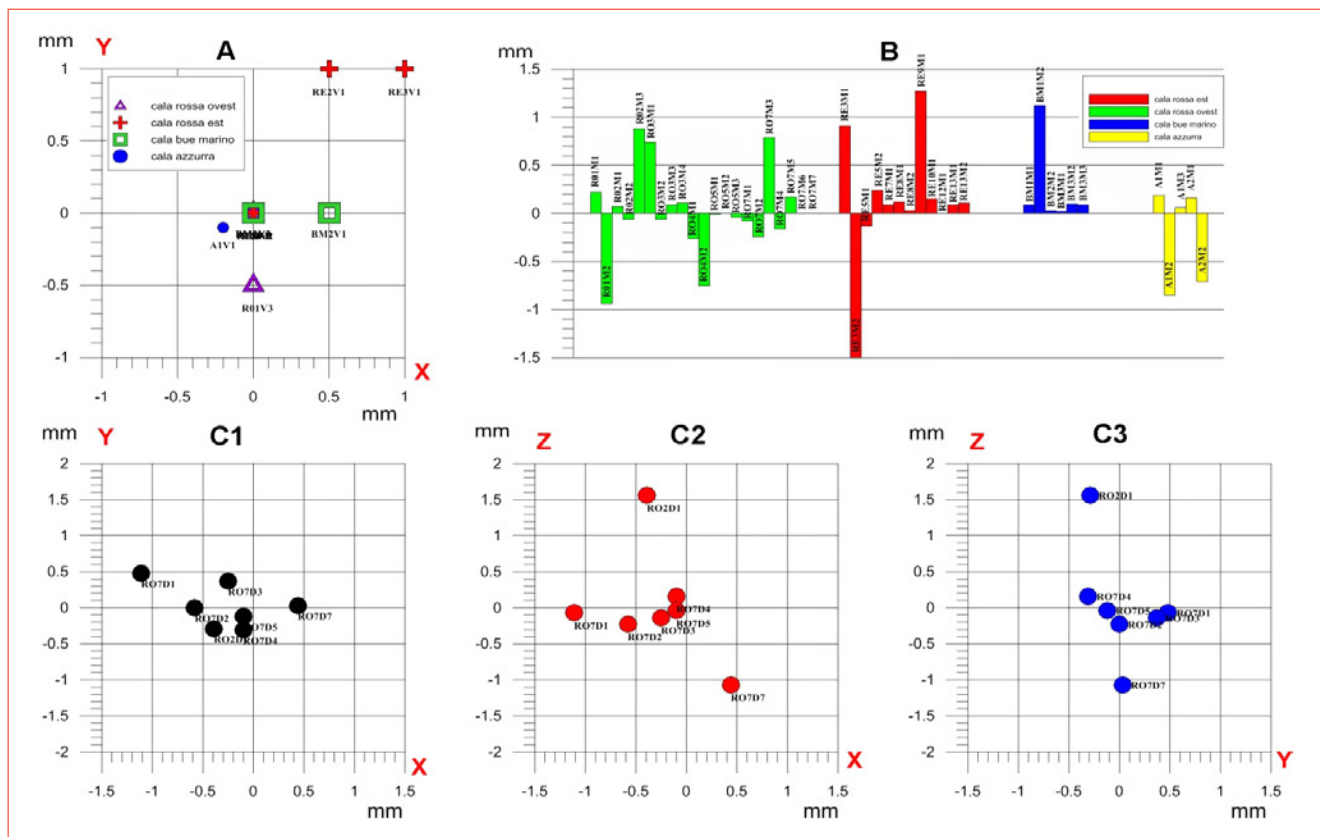
The movements measured by the mechanical joint-meters installed in the three bays are generally lower

than 1mm (Figure 10). Only eight measurement points showed variations over the 24 months exceeding 1 mm and only 1 is greater than 5 mm (RE3M2, a joint in the central part of Cala Rossa).

FIGURE 10 Displacements measured with the mechanical joints gauges: tell tales (A), removable joint-meters (B) and 3D joint-meters (C1, C2 and C3)

The lack of significant movement registered by the integrated monitoring system in the periodic acquisition during the 24 months study can be easily explained with the discontinuous and impulsive behaviour of the rock collapsing processes, and does not exclude the possibility of future single or massive movements. The deepening of the deformation dynamic inevitably requires the upgrading of the current monitoring network with the installation of more sophisticated joint meters in the most critical sites, with in continuum acquisition, data logging and remote communication.
