Historical heritage safeguard: remote sensing by drones for knowledge and emergency

The paper presents an innovative technology for the knowledge of the historical heritage with the use of Unmanned Aerial Vehicles (UAV) able to capture real-time data in inaccessible areas or in emergency situation. The technology, called LARS - Low Altitude Remote Sensing - is carried out by radio-controlled vehicles, commonly called drones, with sensors mounted on carriers operating at low altitude.

■ *Elena Candigliota, Francesco Immordino*

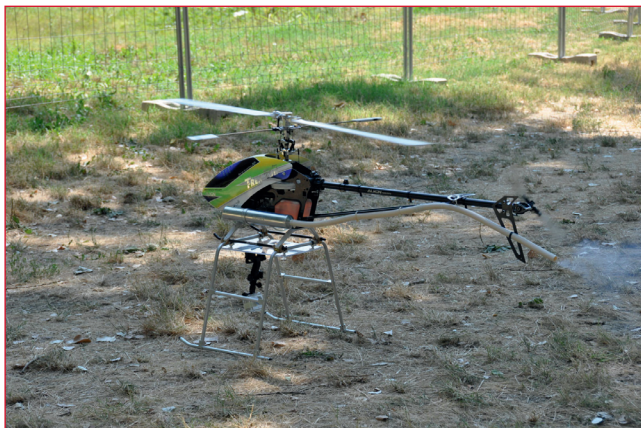
FIGURE 1 Radio-controlled Helicopter with gasoline propulsion

constituted by an electric propulsion quadricopter and a helicopter with gasoline propulsion (Figure 1). On each aircraft a high resolution camera has been installed. The system of the helicopter has been modified by inserting a larger aluminium slide, a high-definition camera, heli commander, flight stabilization system, telemetry for real-time display of altitude, position and fuel levels².

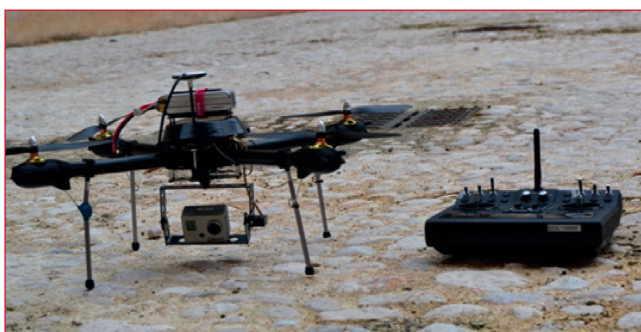
FIGURE 2 Electric quadricopter with RC radio

The used quadricopter (Figure 2) was equipped with a tool for automatic control of positioning and stabilization, both of the aircraft and of the camera, so as to have the entire system perfectly orthogonal to the scene to be captured.

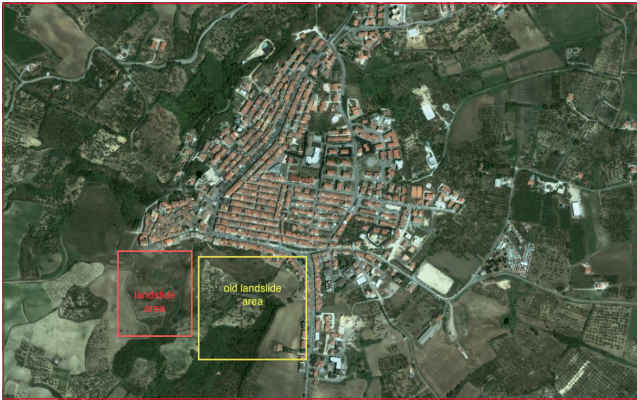
FIGURE 3 San Martino in Pensilis: study area
Source: ENEA on Google map image

in the Municipality of San Martino in Pensilis, located at an altitude of 281 m above sea level in a hilly region of Molise, fits; in the area was planned relief and monitoring of landslide that affects one side of the hill on which the city centre stands (Figure 3) by way of integrated systems of photographic and topographic survey.

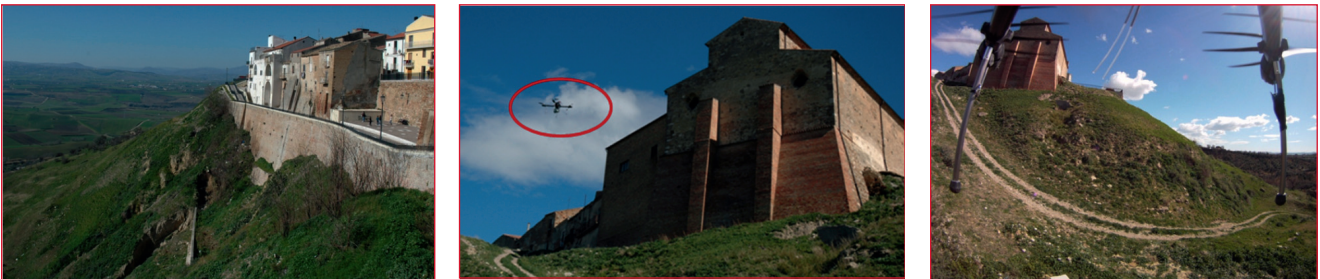
FIGURE 5 Historic centre view (ph. 1), drone in action on the landslide (ph. 2), image captured by drone camera

The drone acquisitions are associated with a survey with terrestrial laser scanning technology³. Subsequently, the aircraft will be equipped with a thermal camera in order to identify areas at different moisture of the landslide and a possible non-effective drainage of rainwater. The collected data will provide information on the spatial distribution of the hydrogeological phenomena for the hazard assessment in the area.

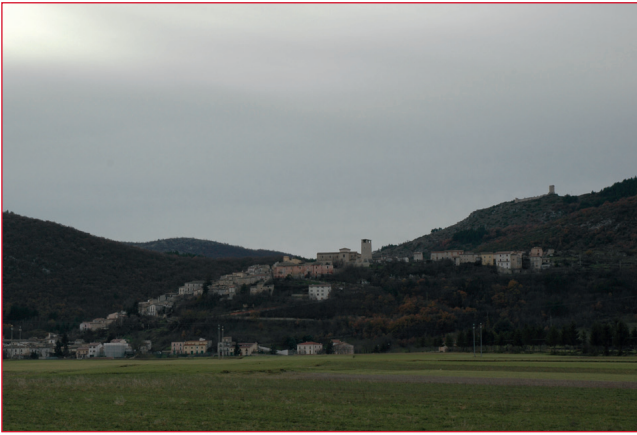
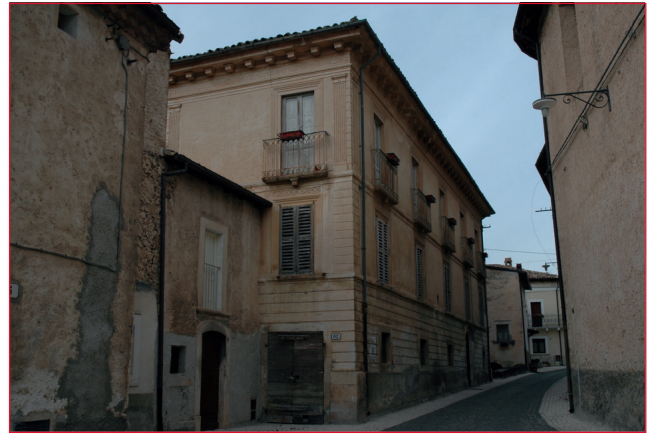
FIGURE 6 Historic centre of Caporciano (ph. 1) and main façade of the building (ph. 2)

This application has been used in the context of integrated analysis⁴ on an aggregate building (Figure 6, ph. 2) in the historic centre of Caporciano (Figure 6, ph. 1), carried out by ENEA researchers with C.A.Sa. architecture office in Pescara; the study predicted laser scanner survey, materials characterization testing, surveys with thermo-camera and detail acquisitions of the roofs through drones.

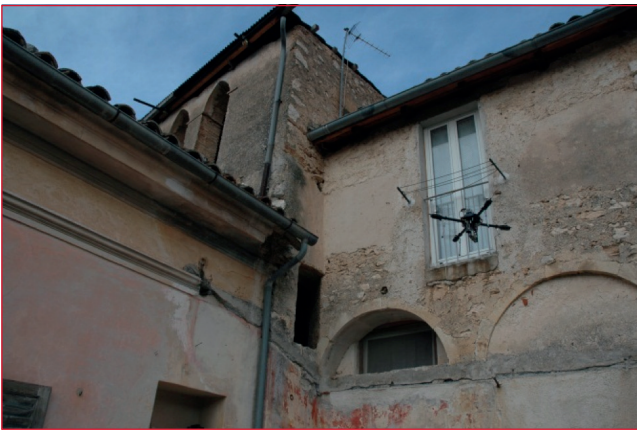
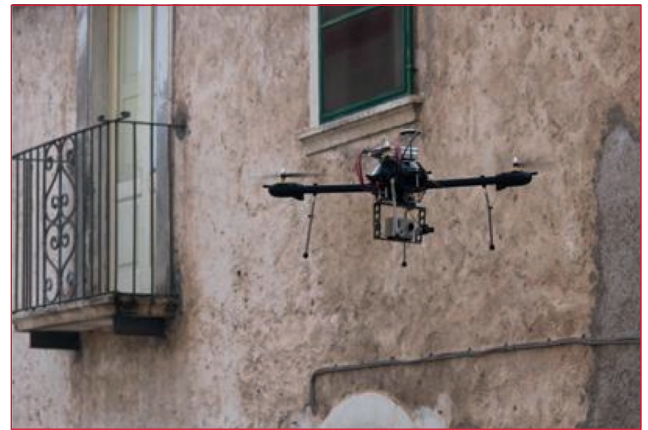
FIGURE 7 Quadricopter during a flight acquisition

not any points of view from other buildings that would allow an overview, a view from UAV (Figure 7) was required in order to verify also the conservation state. The use of integrated methodology with innovative technology represented a valid method of providing information for the assessment of the vulnerability of architectural heritage, considering the restoration and the consolidation of building in complex situations such as old town centres⁴.

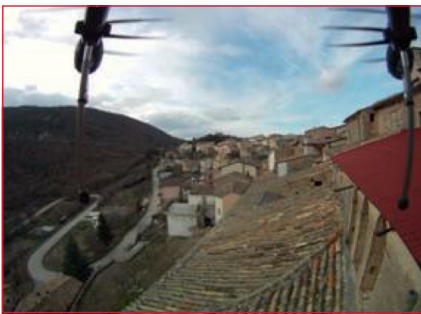
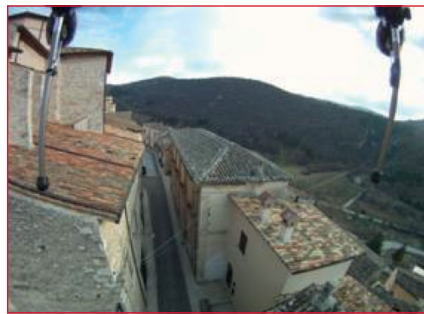
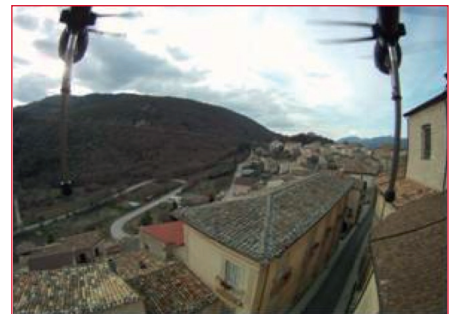
FIGURE 8 View of roofs by quadricopter camera

The technology has been used to survey and check the conservation state of the building roofs. Images at different angles of the building were acquired in order to get different views of the roofs and check their condition (Figure 8).

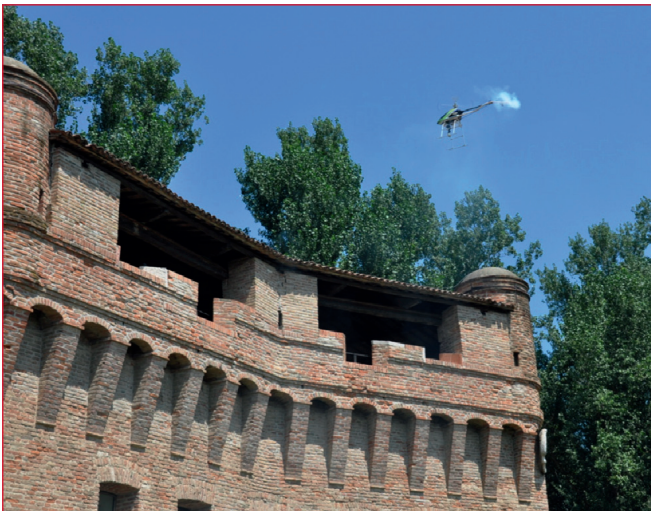
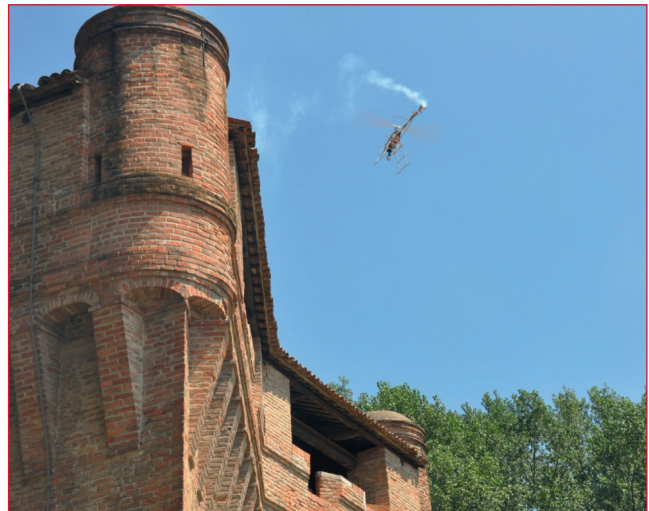
FIGURE 10 Helicopter in action for images acquisitions of damage in Rocca Possente, Bondeno

The fortress, UNESCO World Heritage since 1999, is situated in Stellata place, surrounded by a beautiful landscape on the right bank of the Po river. Four different acquisitions were performed, one for each side⁶. Three acquisitions were carried out with helicopter, the fourth on the main façade through smaller quadricopter; in fact, the presence of the staircase leading to the first floor, a small building facing the fortress and the presence of various obstacles did not leave enough operating

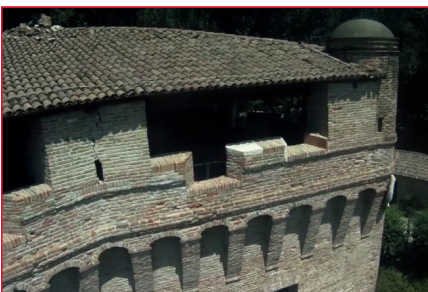
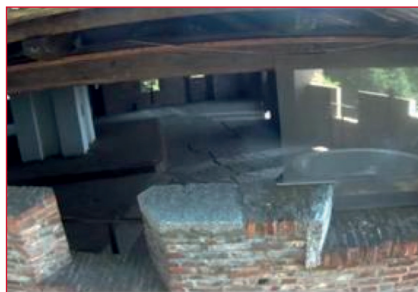
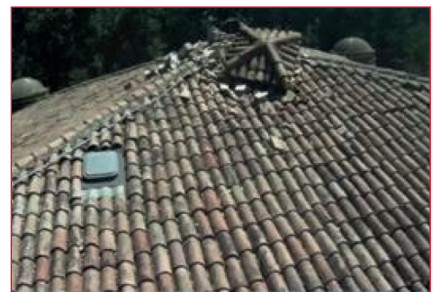
FIGURE 11 Images acquired by helicopter: visible damages on masonry, slab and roof

The acquired images, processed by image analysis using a new classification object oriented method, allowed knowledge of conservation and damage status of the building.

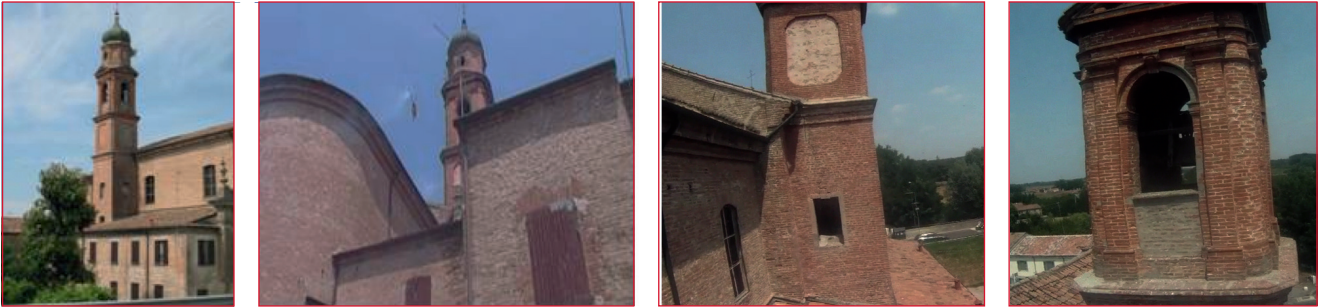
FIGURE 12 Church of San Giovanni in Municipality of Bondeno: view of the bell tower (ph. 1), helicopter in action for steeple image acquisitions (ph. 2), helicopter views (ph. 3&4)

The church of San Giovanni is located in the urban centre, in the entrance of the city coming from Ferrara. The main façade of the church suffered a severe crack from the architrave of the main access portal to the tympanum, visible from the ground⁵. The bell tower showed some cracks but inspecting the top part of the cornices at different levels of the steeple was not possible. So an acquisition from close range and in altitude was needed.

The high-resolution helicopter acquisitions (photos 3 & 4 in Figure 12) have provided technicians and designers with useful information for the safety intervention on the bell tower.

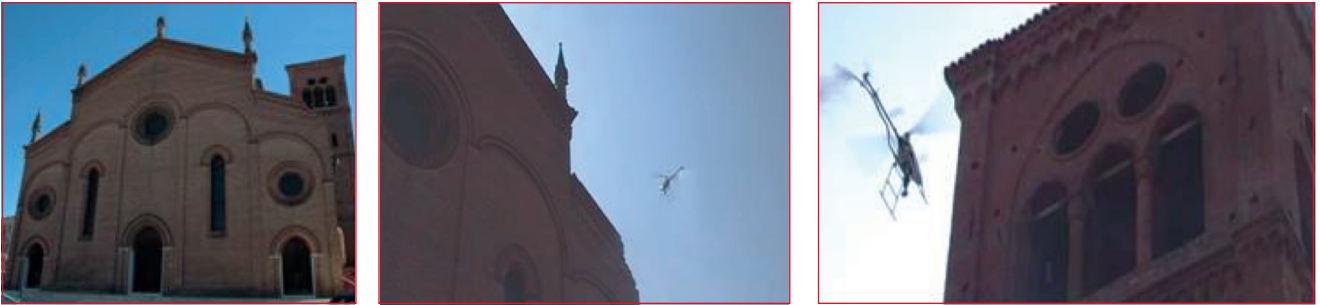
FIGURE 13 Matildica Church façade (ph. 1), helicopter during the image acquisition (ph. 2&3)

The Church of Natività di Maria, called Matildica Church, cathedral in the municipality of Bondeno, is situated in the historic centre (Figure 13).

The acquisitions included the main façade (ph. 2 in Figure 13), the two side elevations and the bell tower in the façade facing the square (ph. 3 in Figure 13). Detail acquisitions (Figure 14) showed damage caused by the earthquake (ph. 2 in Figure 14) but also the conservation state of the architectural and decorative elements (ph. 3 in Figure 14).

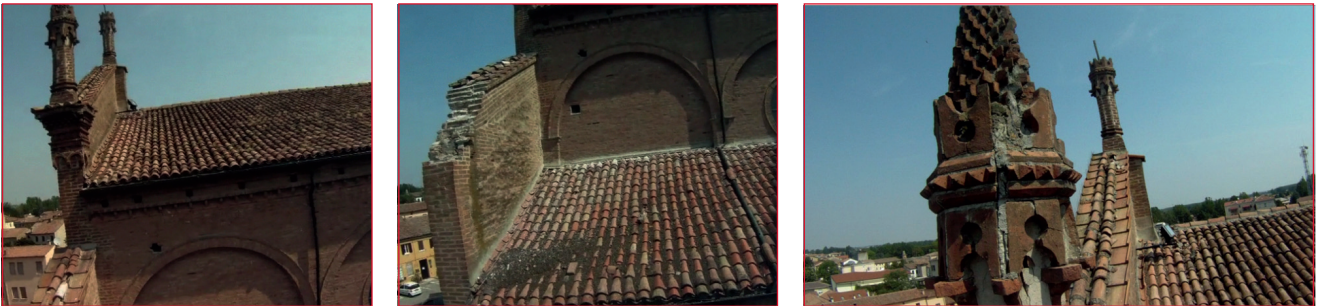
FIGURE 14 Images captured by video-camera on the helicopter

The church had serious cracks in the apse and on the vaults with some partial collapse. In the bell tower the detachment of the internal stairs from the perimeter walls occurred and the vaults are damaged⁵. Firefighters intervened on the top of the church façade to remove a detached spear (ph. 1&2 in Figure 14), to prevent its overturning.
