THE PIANURA PADANA EMILIANA EARTHQUAKE

Damage to religious buildings due to the Pianura Padana Emiliana earthquake

■ *Elena Candigliota, Bruno Carpani, Francesco Immordino, Alessandro Poggianti*

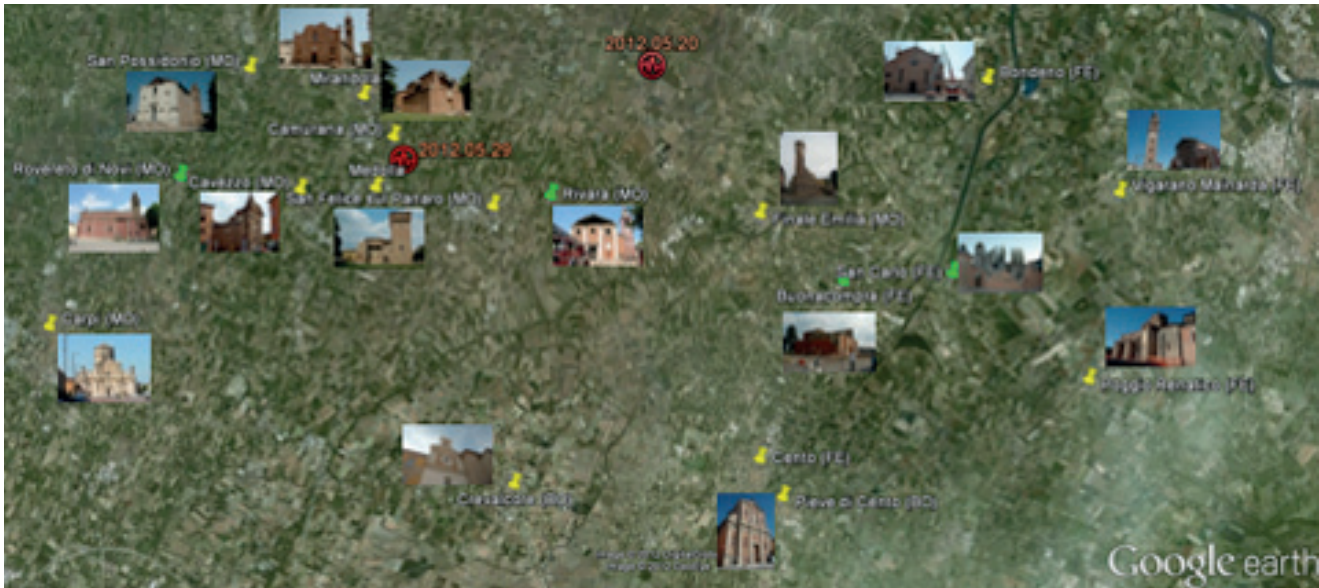
FIGURE 1 Localization of the epicentres of the main events, of the city visited and images of their monuments become the symbol of this earthquake (on image by Google Earth)

Many historical buildings are located in high-risk areas; there are whole towns of particular architectural value with churches and palaces worth preserving. Unfortunately, the Emilia-Romagna earthquake revealed, once again, the vulnerability of the historical Italian heritage. In Figure 1, the earthquakes epicentres are marked in red, and the towns and places (in yellow and green, respectively) most affected are shown, each with the image of the building become symbol of this earthquake. The historic centres have lost their symbols, the places that characterized the city – often meeting places of the community – are now inaccessible and towns show ghostly landscapes with piles of rubble and impassable fences (Figs. 2 & 3). Figure 2 shows the historic centre of Finale Emilia a few hours after the

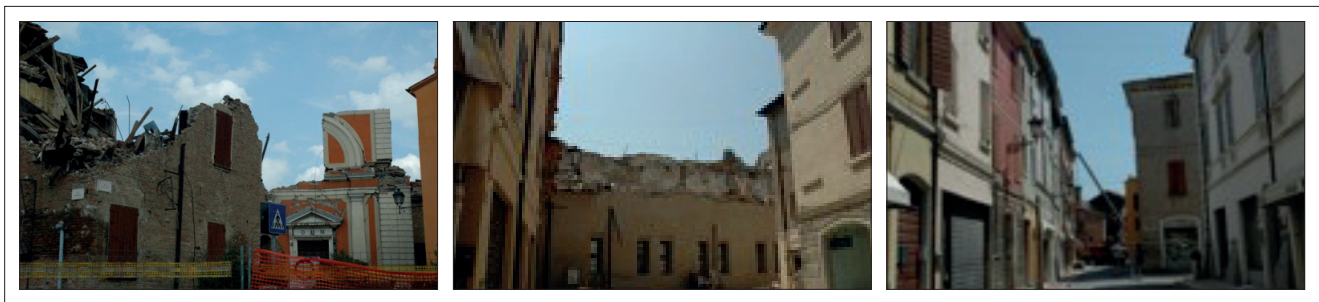
FIGURE 3 Historic centres of San Felice sul Panaro (photo 1) and Mirandola (photos 2 & 3)

quake of May 20th. The first photo of Figure 3 shows a view of the square in front of the cathedral of San Felice sul Panaro, with the church damaged by repeated shocks; photos 2 and 3 of the same figure show two views of the historic centre of Mirandola, the first close to the cathedral whereas the second offers a view of what remains of the church of San Francesco.

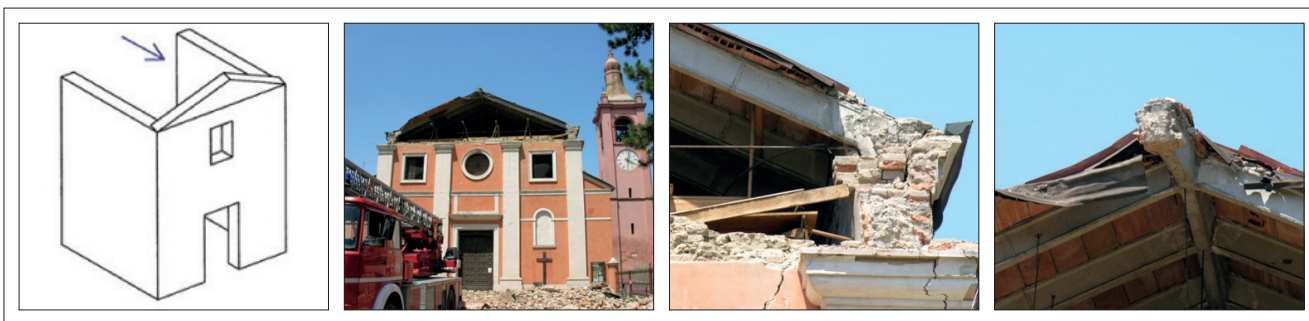
FIGURE 4 Church of Natività, Rivara, San Felice sul Panaro (drawing by [2])

One of the most common failure mechanisms in cases of severe damage was the out-of-plane collapse of the tympanum. In some cases the damage displays a horizontal crack and the collapse of the entire macroelement (Figs. 4 & 5).

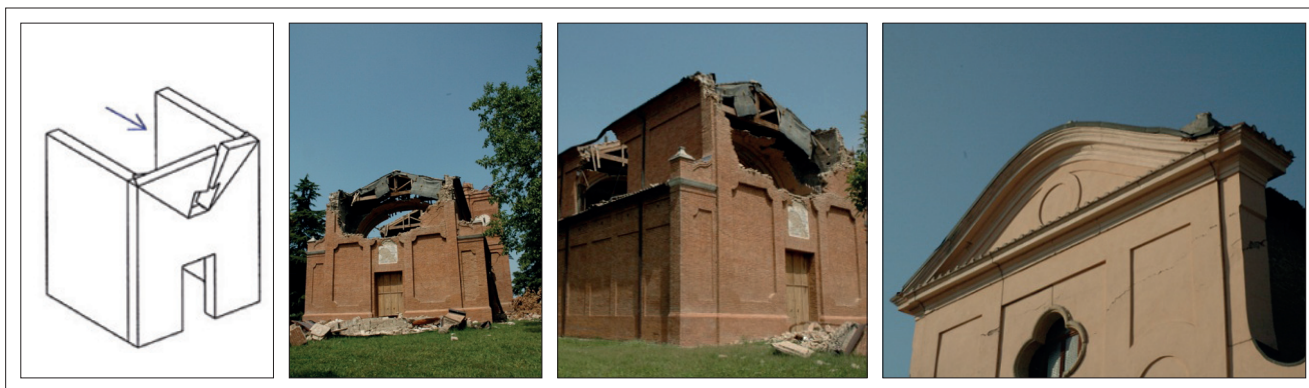
FIGURE 6 Church of S. Luca, Camurana, Medolla (photos 1&2), Church of San Francesco d’Assisi, Finale Emilia (photo 3) (drawing by [2])

In other cases, the collapse occurred with a V shaped crack and the crumbling of the masonry, as in the badly damaged church of S. Luca in Camurana (photos 1 & 2 in Fig. 6). Another case of V shaped crack is shown in the church of S. Francesco d’Assisi in Finale Emilia (photo 3 in Fig. 6).

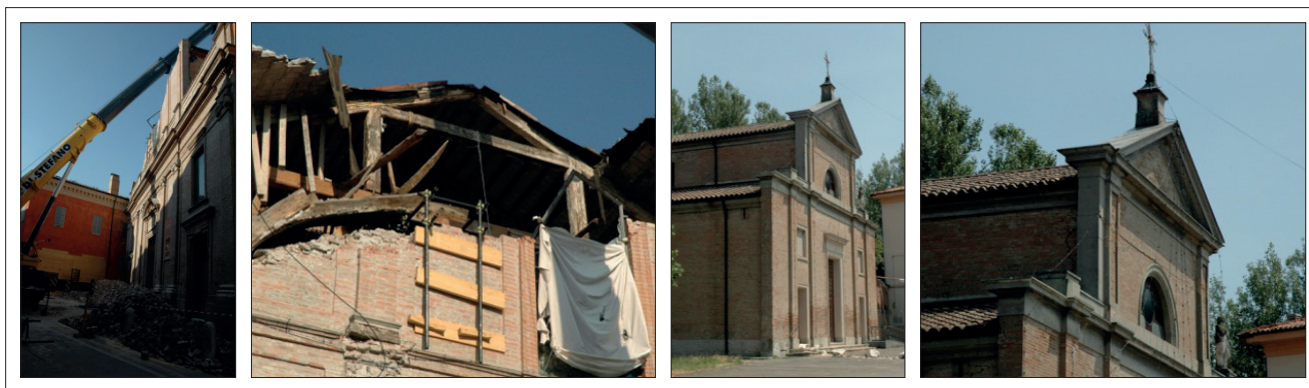
FIGURE 7 Church of SS Filippo e Giacomo, Cathedral, Finale Emilia (photos 1&2), Church of Santi Senesio e Teopompo Martiri, Medolla (photos 3&4)

There have been cases of overturning of the tympanum and disaggregation of the underlying part of

masonry in such a way as not to make the collapse mechanism clear (photos 1 & 2 in Fig. 7), or cases of horizontal cracks in a position lower than the base of the tympanum (photos 3 & 4 in Fig. 7).

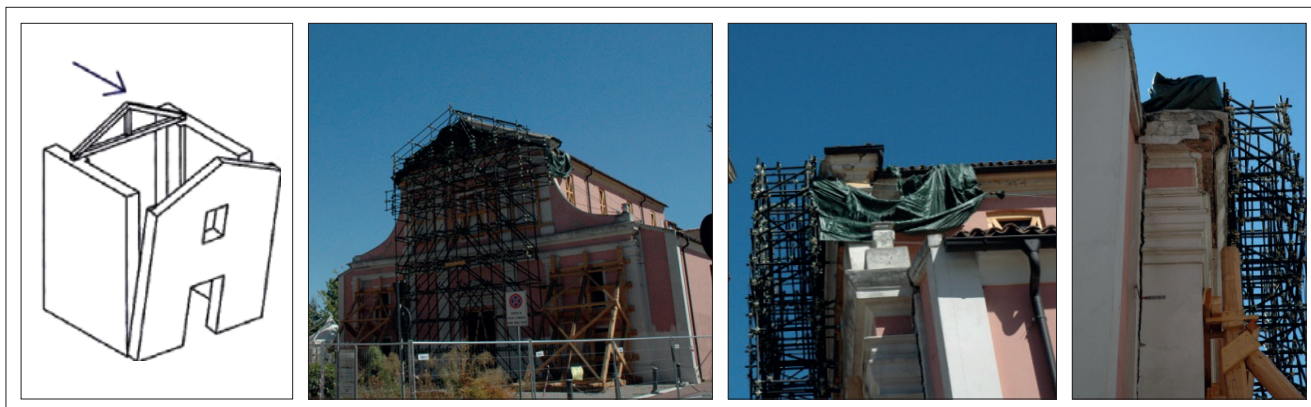
FIGURE 8 Church of Natività della Beata Vergine Maria, Vigarano Mainarda (drawing by [2])

Another mechanism observed in many damaged churches is the detachment with consequent overturning of the façade as in the church in Vigarano Mainarda (Fig. 8). The beginning of the mechanism in the top part is quite widespread, and required many interventions for safety with provisional tie rods (photo 3 in Fig. 12).

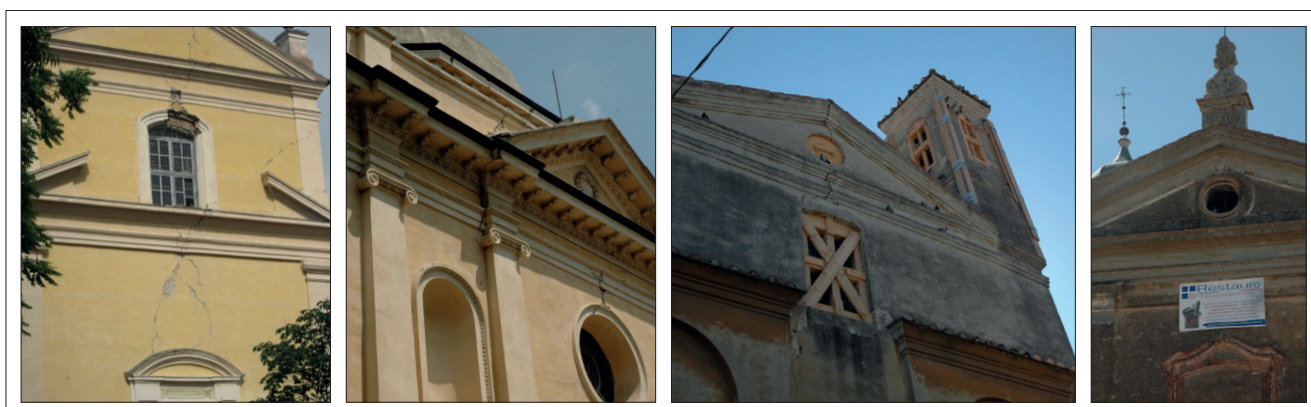
FIGURE 9 Church in Finale Emilia (photo 1); Church of Madonnina, Mirandola (photo 2); Church of SS. Rocco e Sebastiano (photo 3), Pieve di Cento; Church of S. Giovanni, Bondeno (photo 4)

In plane, the damage mechanism of the façade – often with vertical cracks from the tympanum to the architrave of the entrance portal through the rose windows of the churches – has been observed too. Figure 9 shows the various severity levels of this type of damage.

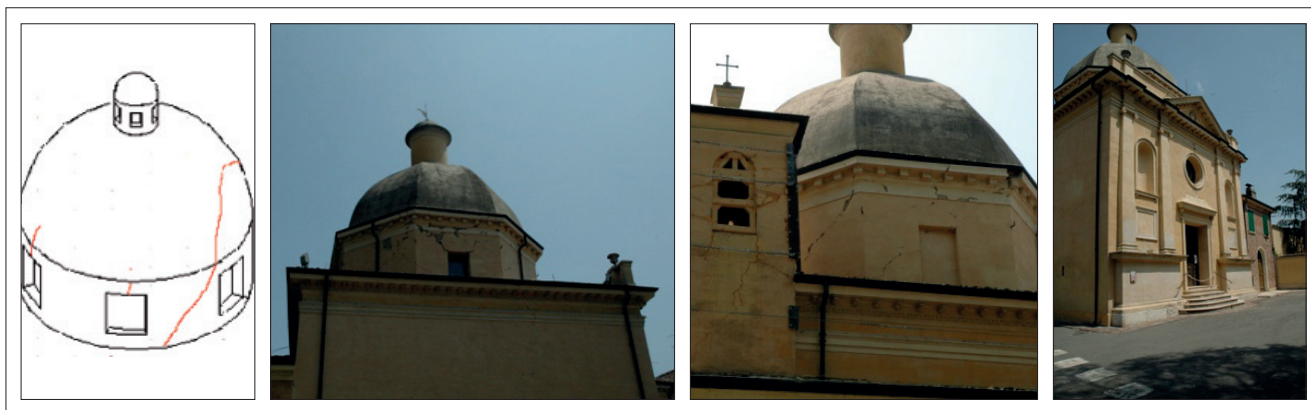
FIGURE 10 Church of the Madonnina, Mirandola (drawing by [2])

The figures below show some cases of this typology of damage. The drum of the Church of Madonnina in Mirandola was seriously damaged, from the outside it is not possible to see any damage to the dome because of the covering.

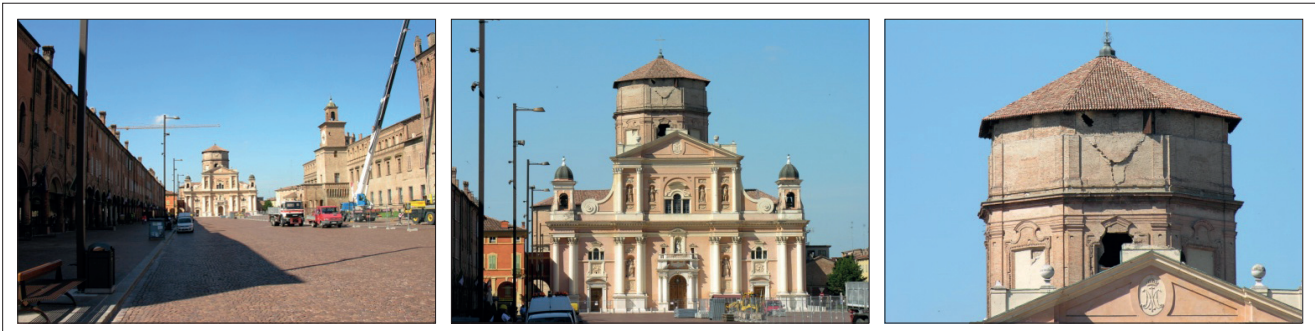
FIGURE 11 Cathedral of S. Maria Assunta, Carpi (MO)

The *tiburium* of the cathedral of Carpi shows clearly visible cracks in the front facing the square (Fig. 11), whereas the dome of the church of S. Maria Maggiore in Pieve di Cento has completely collapsed and its drum is now bounded with provisional tie rods (Fig. 12).

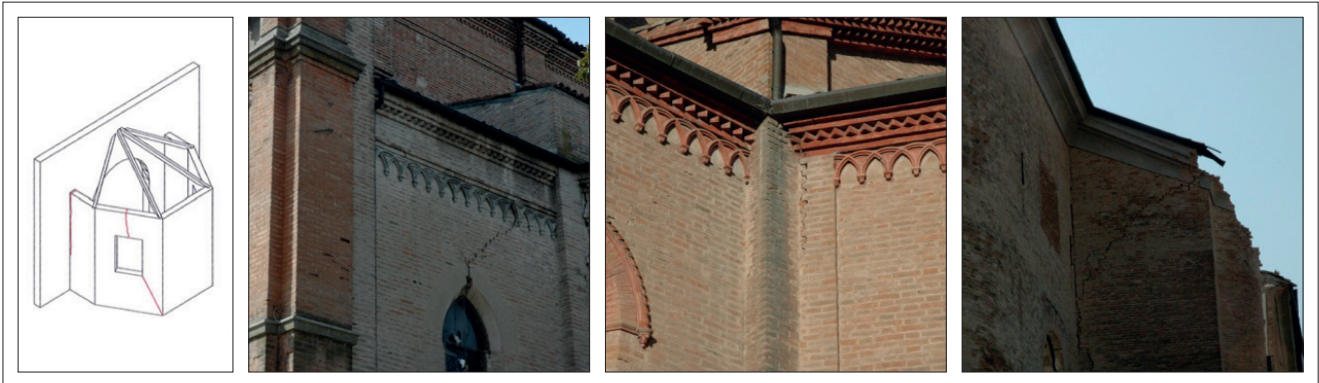
FIGURE 13 Church of S. Silvestro, Crevalcore (BO); Church of San Michele Arcangelo, Poggio Renatico (FE); Church of San Possidonio, San Possidonio (MO); (drawing by [2])

Significant shear cracks are present in the lateral chapels of several churches. The detachment of the outer walls of the chapels from the walls of the church and shear cracks in the walls of chapels and side aisles are often observed (Fig. 13).

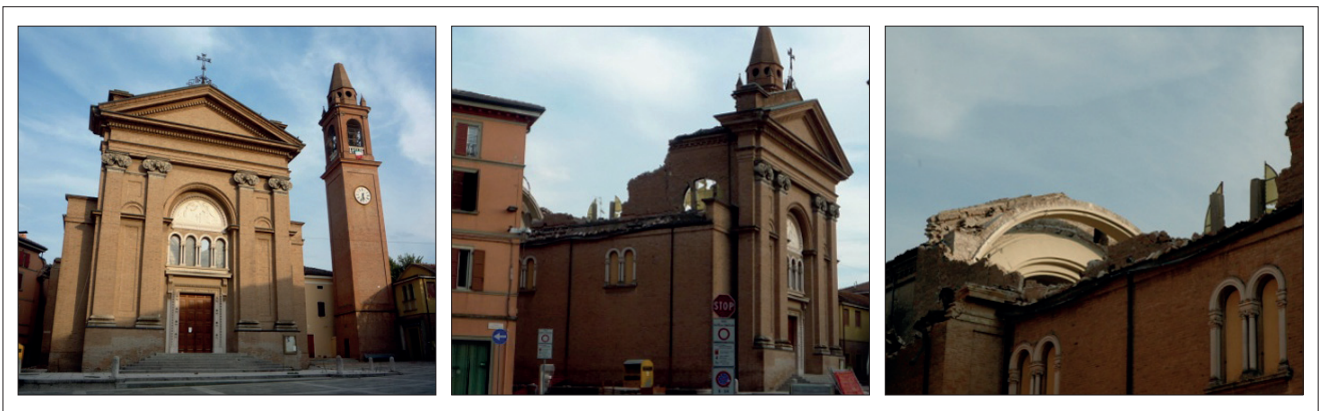
FIGURE 14 Church of Sant'Egidio Abate, Cavezzo (MO)

The figures below show some important collapses of structural parts. The church of S. Egidio Abate in Cavezzo was particularly damaged with the collapse of roof and vault. The first photo of Fig. 15 shows the church of S. Francesco, already severely damaged by the earthquake of May 20th, almost completely collapsed after the event of May 29th.

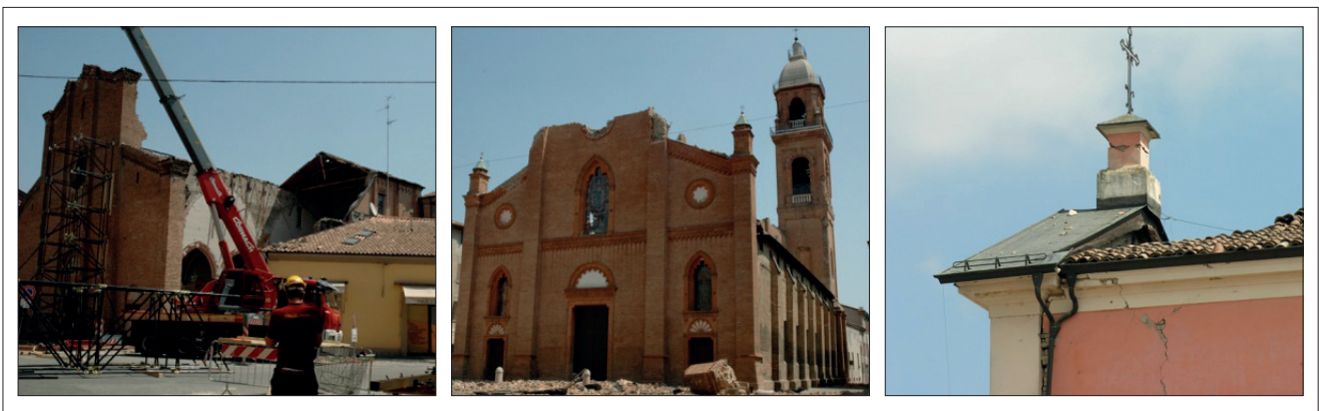
FIGURE 15 Church of S. Francesco (photo 1) and Cathedral (photo 2) in Mirandola; Church of Santa Caterina d'Alessandria, Rovereto di Novi (photo 3, by courtesy of P. Clemente)

Already damaged by the earthquake of May 20th, also the cathedral of Mirandola, with the event of May 29th, saw the partial collapse of the façade and the roof. The roof

collapse in the badly damaged church of Santa Caterina d'Alessandria in Rovereto di Novi, in Novi di Modena town, has become infamous for causing the death of the priest. Little is left – except for the perimeter walls and piles of rubble to recover – of the church of S. Martino in Buonacompra, and of the Oratorio Ghisilieri in San Carlo, in Sant'Agostino town.

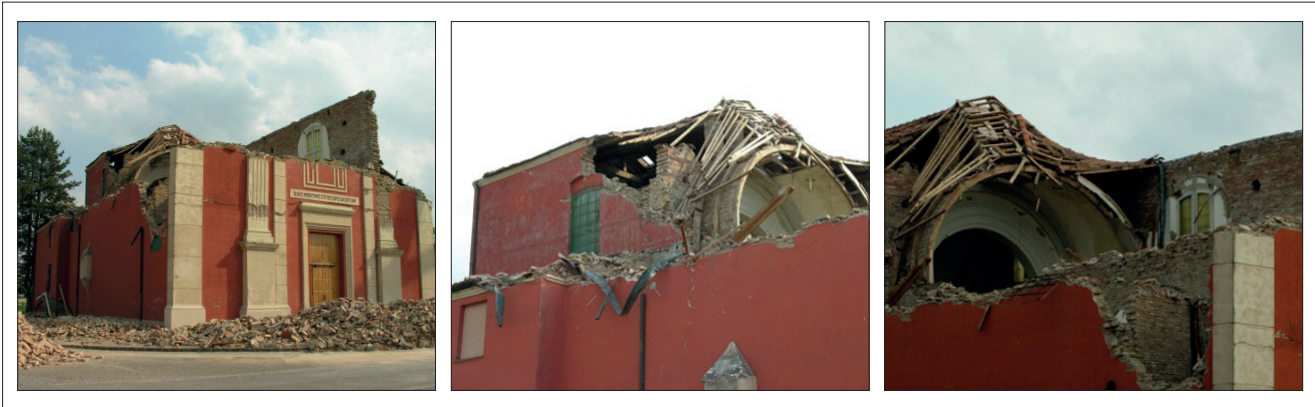
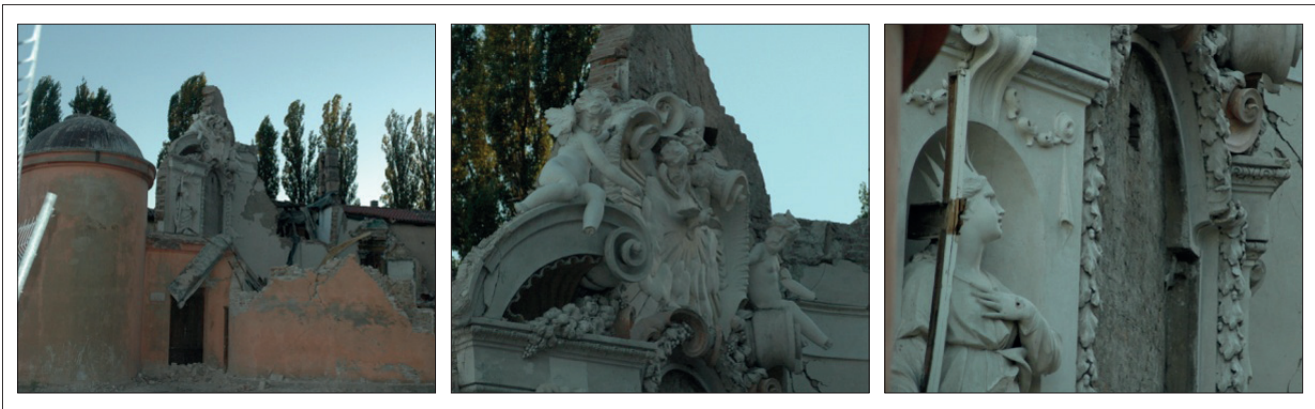
FIGURE 16 Church of S. Martino, Buonacompra, Cento (FE)

FIGURE 17 Oratorio Ghisilieri, San Carlo, Sant'Agostino (FE)

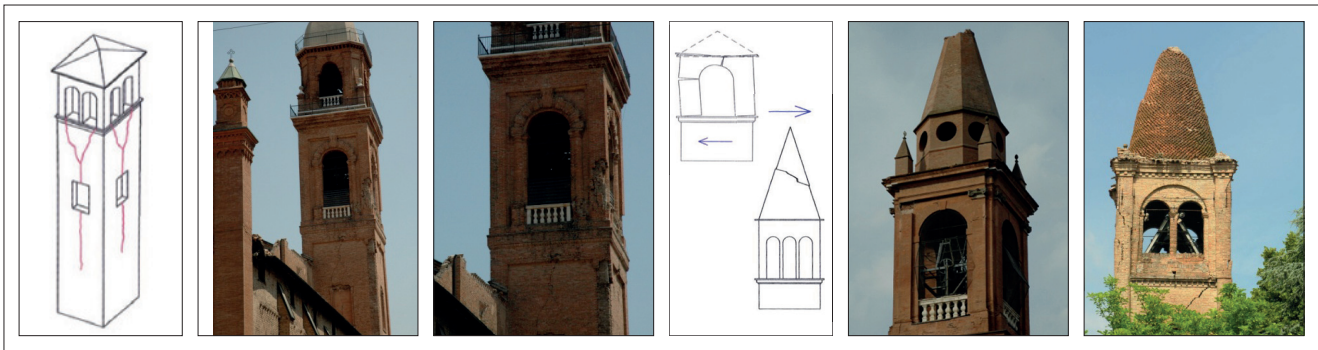
FIGURE 18 Steeples of: Cathedral, Mirandola (photos 1 & 2); Church of Sant'Egidio Abate, Cavezzo (photo 3); Church of Santa Caterina d'Alessandria, Rovereto di Novi, (photo 4, by courtesy of P. Clemente), (drawings by [2])

tion (frequent cases in the area where inclined steeples are found) and to masonry in bad state of conservation. The bell cells, with large openings, show serious shear cracks in the little columns, with sliding in the most severe cases (Fig. 18). Some of them are disaggregated under the action of the earthquake, others have been

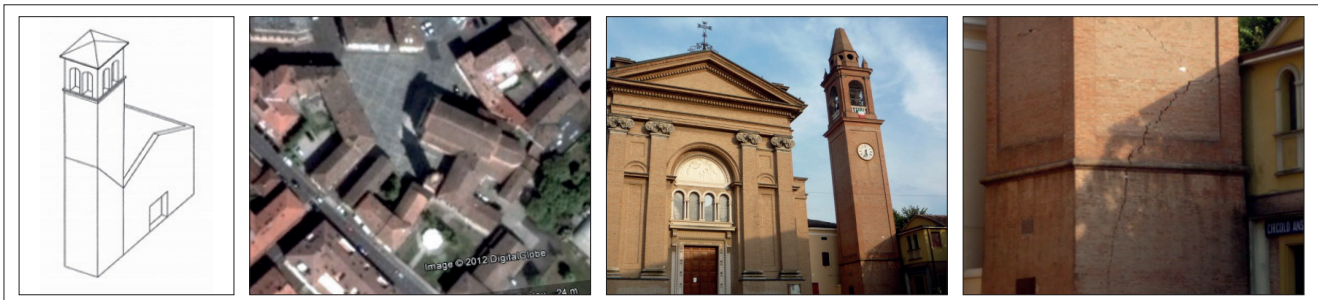
FIGURE 19 Steeple of Sant'Egidio Abate Church, Cavezzo (drawing by [2], photo 1 by Google maps)

removed from firefighters, others made safe. When the steeple is placed in contact with other structures of lower height, this can cause local damage; an example is the bell tower of church in Cavezzo (Fig. 19). In the pictures in Fig. 20, two cases of severe damage are reported; the first two photos show the bell tower

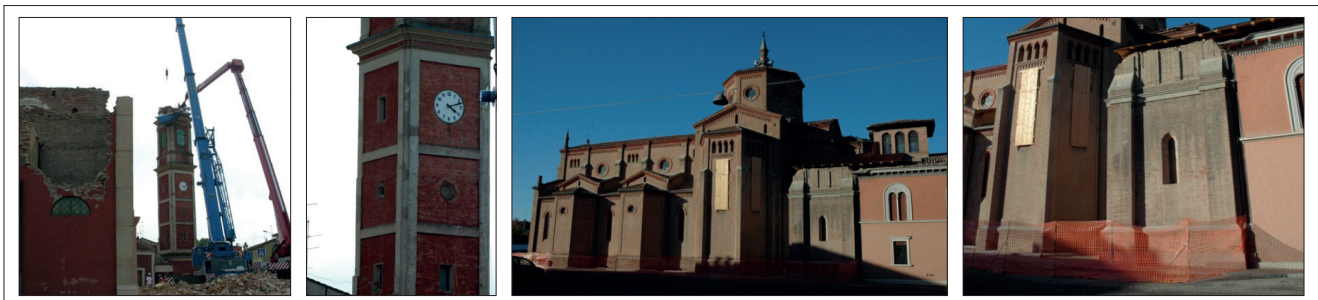
FIGURE 20 Steeples of: Church of S. Martino, Buonacompra, Cento (FE), Church of S. Michele Arcangelo, Poggio Renatico (FE)

of the Church in Buonacompria during the demolition. Photo 2 shows the severe shear two-level damage, due to torsional stress, that led to the decision to demolish the tower. The last two pictures in Fig. 20 show the church of S. Michele in Poggio Renatico deprived of its bell tower, blown up as a threat to public safety due to its serious structural problems.

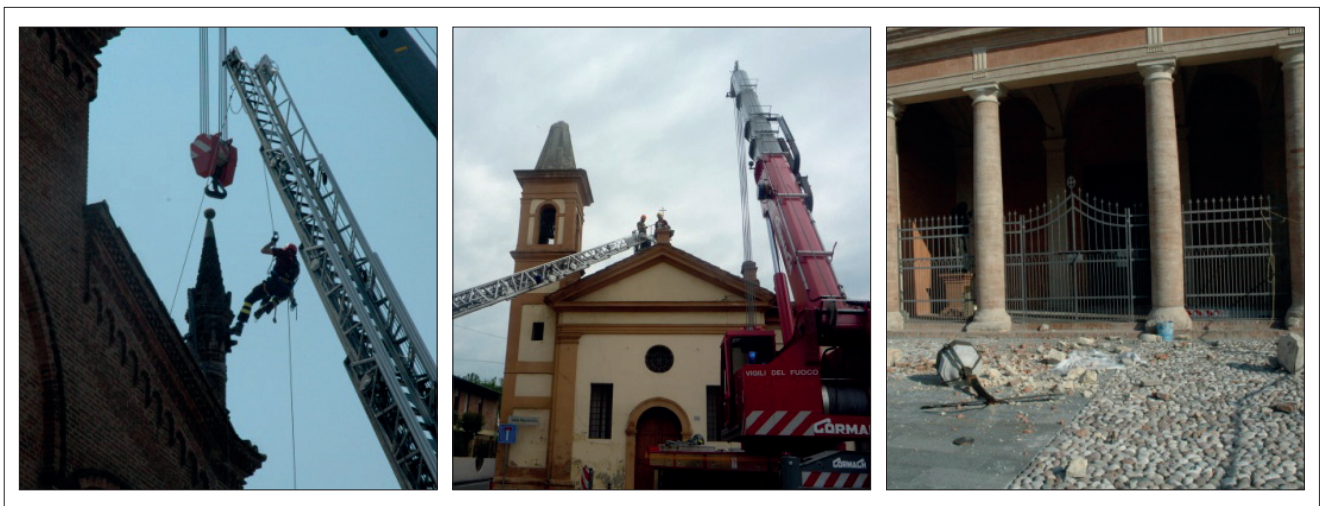
FIGURE 21 Church Matildica and Church of the Sante Grazie in Bondeno; Church of San Bartolomeo, Finale Emilia

Firefighters intervened many times on the top of the church façades and bell towers to remove slender elements, such as statues and spears, with vulnerability due to their low vertical load and weight, which provides a limited stabilizing effect in regard to the turnover. Spiers, crucifixes, statues that fall from the church roofs, often with metal anchors

weak or too short, represent a danger often underestimated.

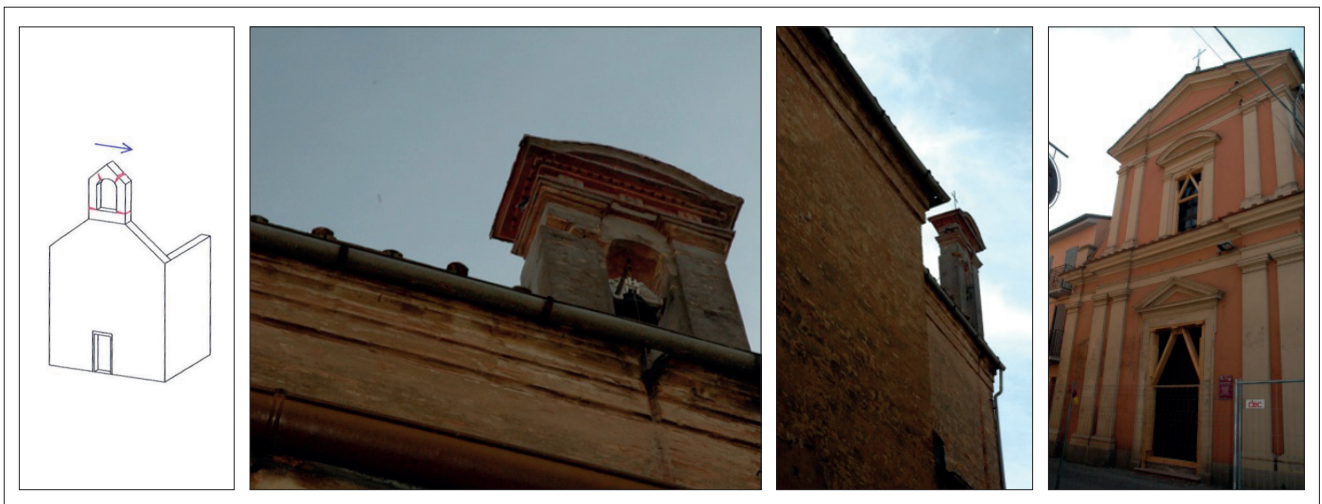
FIGURE 22 Church of Santa Croce, Crevalcore (BO), (drawing by [2])

Many interventions have been made to put the bell cells in safety and, in some cases, disassemble them. In other cases, overhang host bells have reported shear cracks with displacements due to sliding along the shear cracks, as in the church of Santa Croce in Crevalcore (Fig. 22).
