Cliffs and quarries in the eastern coast of the Favignana island (Sicily, Italy)

DOI 10.12910/EAI2015-071

■ L. Falconi, A. Peloso, A. Screpanti, A. Tati, V. Verrubbi

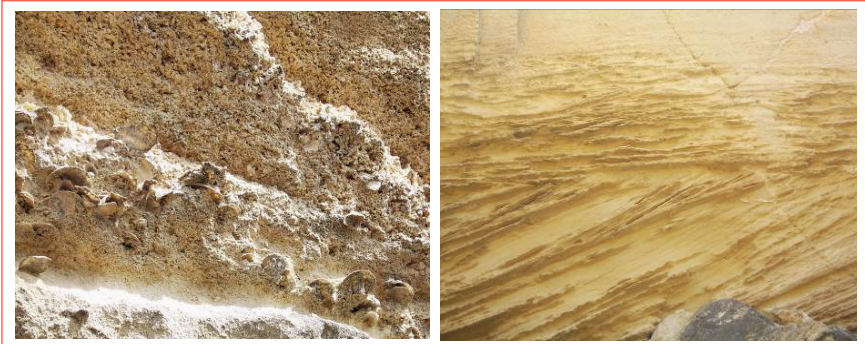
FIGURE 1 Bivalves (left) and cross-bedded layers (right) in the calcareous sandstones

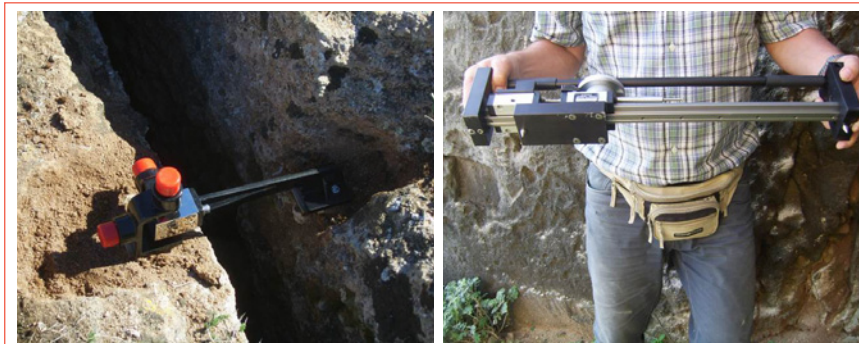
FIGURE 3 3D joint meter installed on the giant joint of the plateaux of the west side of Cala Rossa (left) and the removable deformer during the measurement survey

A direct measurements systems was implemented with mechanical joints gauges of different kind (tell-tale, removable joint-meters, 3D joint-meters; Figure 3) in relationship with the different characteristics of the walls, discontinuities and types of movement to be recognised (one-dimensional or three-dimensional). These three mechanical joint-meters systems allow to measure relative displacements between two reference pins or two anchors positioned across the joints with a resolution of a hundredth of

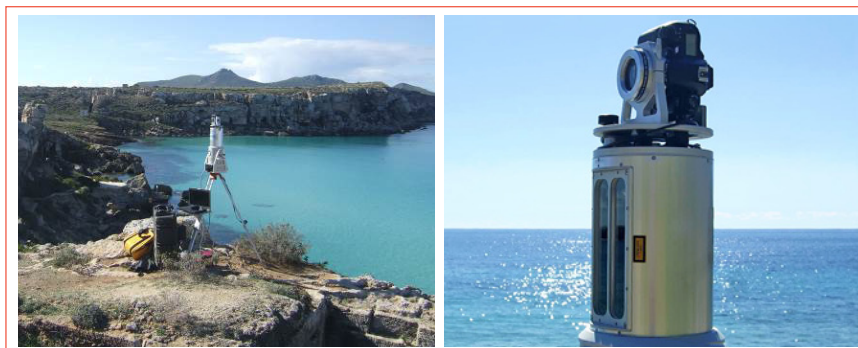
Laser scanner survey [17] were performed using a laser scanner (Riegl Z360) integrated with a high resolution digital camera (Nikon D100; Figure 4). Two Laser Scanner acquisitions (October 2012 and October 2013) were performed in all the three bays, positioning the instrument in four stations in Cala Rossa, four in Cala del Bue Marino and five in Cala Azzurra. In order to compare subsequent temporal scanning [18, 19] and re-calibrate the instrument with a precision of mm, eight fix targets and ten mobile targets around the scan points (scanpositions) were materialized as a Cartesian coordinates system.

FIGURE 4 Laser scanner instruments during the acquisition survey in Cala Rossa
